**Flood Control Project Maintenance  
Levee Inspections**

**Fall 2016 Levee Maintenance Deficiency Summary Report**

**Sacramento River Basin**

| <b>RD0010</b> | Overall LMA Rating | Total LMA Miles | * Overall LMA Threshold Percent is less than 10.00%; however, U Rated Miles are present, so the Overall LMA Rating is M instead of A. | | | | | |
|---|---|---|---|---|---|---|---|---|
| <b>Reclamation District No. 0010 Honcut</b> | <b>M *</b> | <b>21.82</b> | | | | | | |

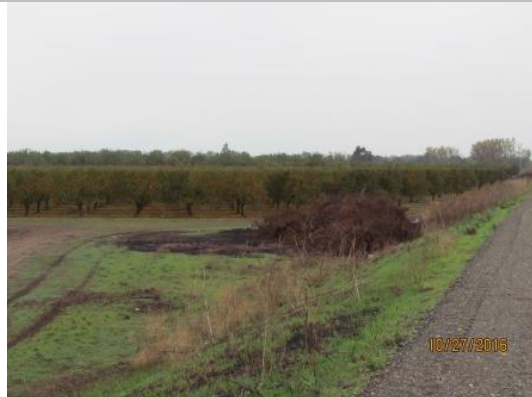
Photo 1 of 1 : FA\_2016\_RD0010\_165\_7\_20161103\_00012.jpg

View of pruning's at landside levee toe looking downstream. Fall 2016.

| Remove pruning's from levee toe. Fall 2016. | | | | | |

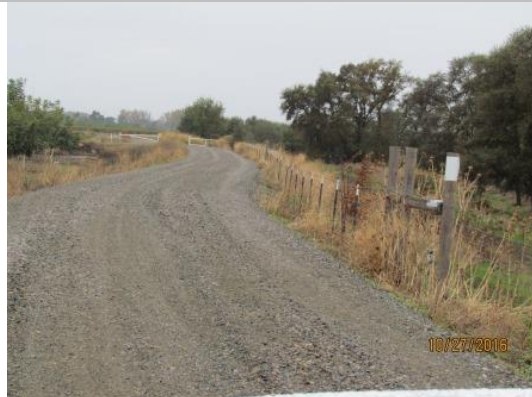
Photo 1 of 1 : FA\_2016\_RD0010\_165\_8\_20161103\_00013.jpg

| Unpermitted fence on waterside levee hinge point. Fall 2016. | | | | | |

View of an unpermitted fence on waterside levee hinge point. Fall 2016.

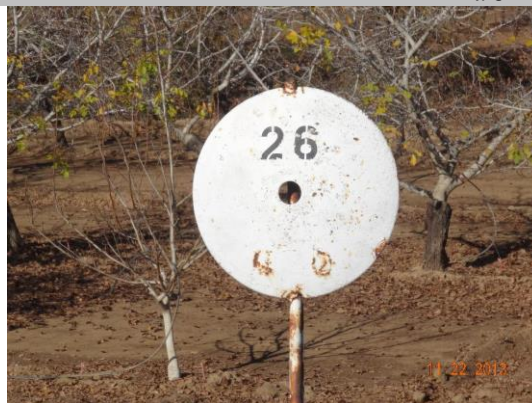
Photo 1 of 2 : UCIP\_FA\_2016\_24842\_44764.jpg

Marker visible on waterward side--No. 26.

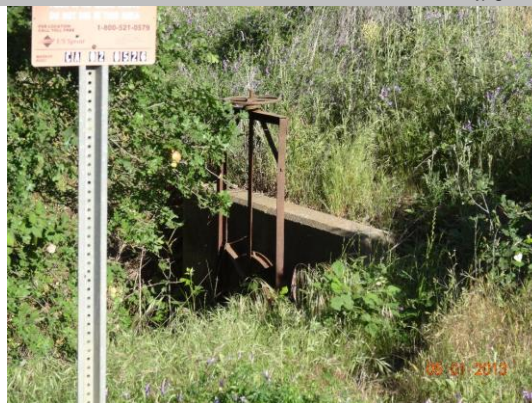
Photo 1 of 2 : UCIP\_FA\_2016\_24883\_44820.jpg

| FS_ID:24883<br>DS_ID:21308<br>EP_NO: N/A<br>Repair Type: Non-Urgent<br>Crossing Status: Found<br>UCIP Comments: Dense vegetation limits the inspector's visibility to identify signs of pipe failure (leaks) along the slope. Recommend removing vegetation along pipe alignment to conduct proper inspection of structure and appurtances.<br>FIELD_STRUCT_DESC: 24-inch pipe through the levee, 12.0 feet below the crown. Two CM cutoff walls around pipe at both shoulders. Flap gate on the waterward end. Slide gate on the landward end. Concrete headwall at the landward toe. (USACE-1953). This entry matches the Drainage or Irrigation Structure referenced in O&M manual (Station 192+33).<br>FS Date: 5/1/2013 | | | | | |

View of slide gate and concrete headwall located on landward side.
